APRIL 2014 NEWSLETTER

The Group

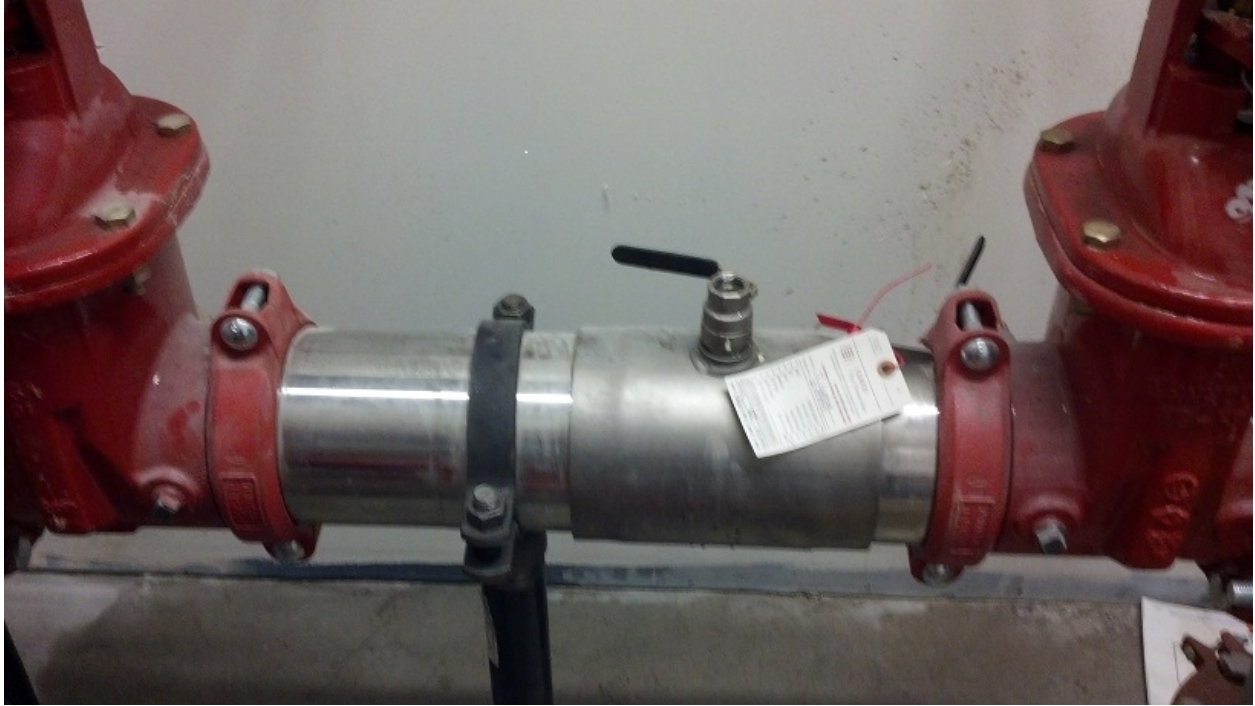
Another item of interest for the month was something I came across in my City last week. I’m sure many of you are aware of this, but because I am not a BAT, I had no idea that pipe supports and earthquake straps could cause such a problem. Maybe I can save someone else a headache.

This is a 6" Ames/Colt 200 DCVA on a fire system. To access the internal checks, the outer sleeve is loosened and actually slides left. The bracing is mounted in concrete on the floor and even if the top of the bracket is removed, it is still not possible for this sliding action due to the bottom of the brace. The Watts 957 RP is designed the same way, and I suppose others. Needless to say, the placement of pipe supports are very important when these types of assemblies are installed.

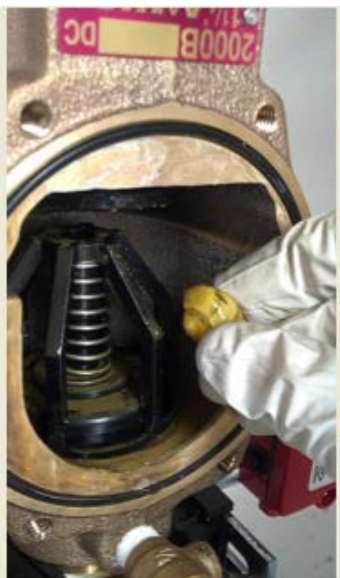
Anyone for a little escargot? No extra charge!!

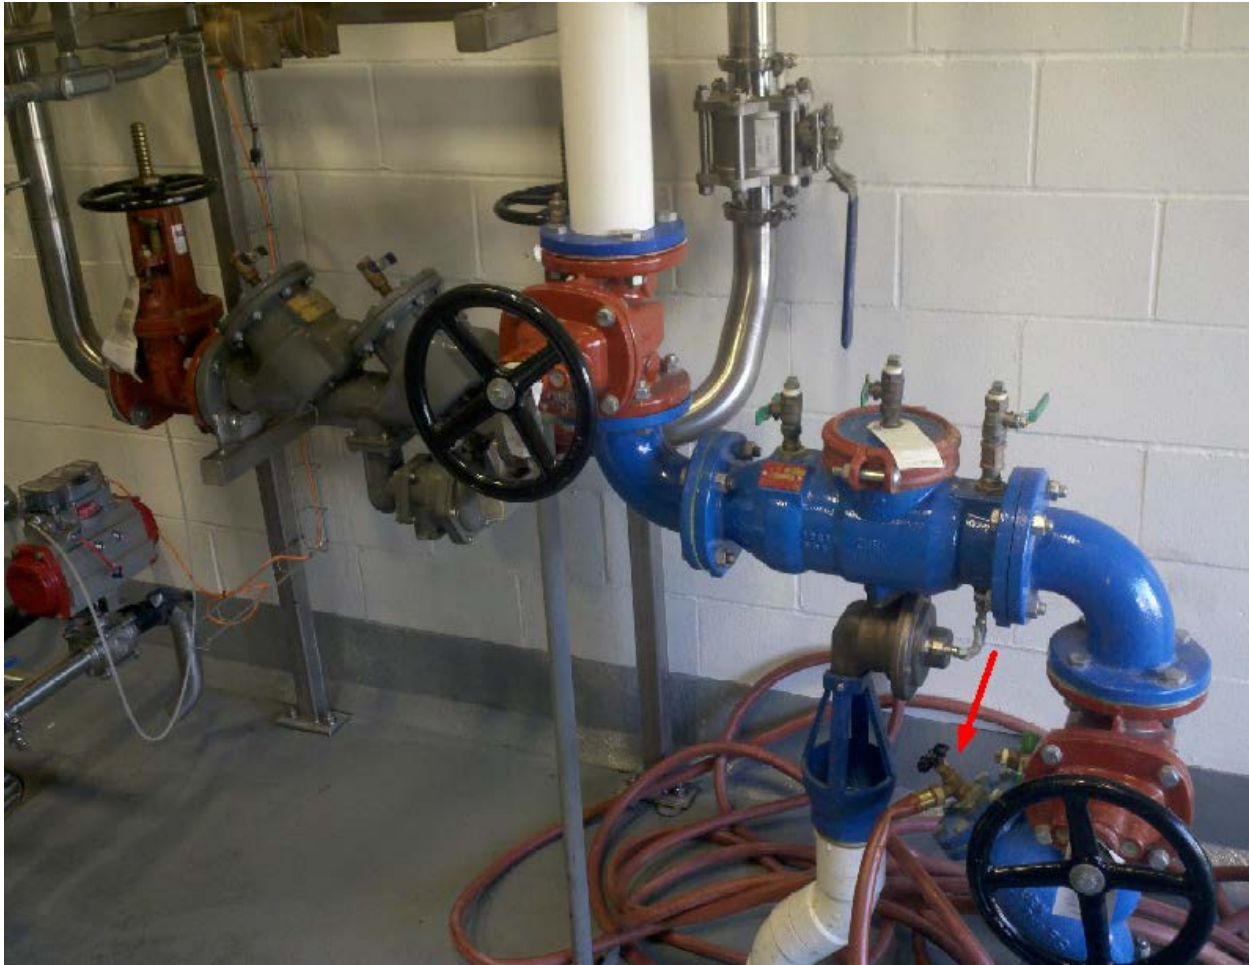
I have been coming across a lot of this during reoccurring inspections of facilities listed in our database as Premise Isolation (accepted inside the building). This plumbing modification was constructed with good intention. Replacing the companion flange plug with a hose bib & hose makes it easy to conveniently flush the collected strainer debris into the sewer. Periodic flushing of the strainer maintains optimum flow and purges debris upstream of the backflow assembly that may otherwise jam an assembly valve and create a fail.

If backsiphonage were to occur and the backflow assembly worked the way it is suppose to, all of the backsiphonage energy would be directed to the unacceptably attached bib & hose. When I walked into this facility the hose was down into a floor drain (sewer).

My requirement(s) directed to the responsible party are to immediately remove the hose. The hose bib shall be replaced with the original plug a.s.a.p. On the best of occasions the companion flange was replaced with a blind flange or the companion flange plug was actually “sweated” in place permanently.
